# Technical Bulletin

Bulletin No: TCH-27-008 Rev 001

Subject: **Recall of Bendix® EC-80™ Electronic Control Units (ECUs) used in Towing Applications – Paccar®**

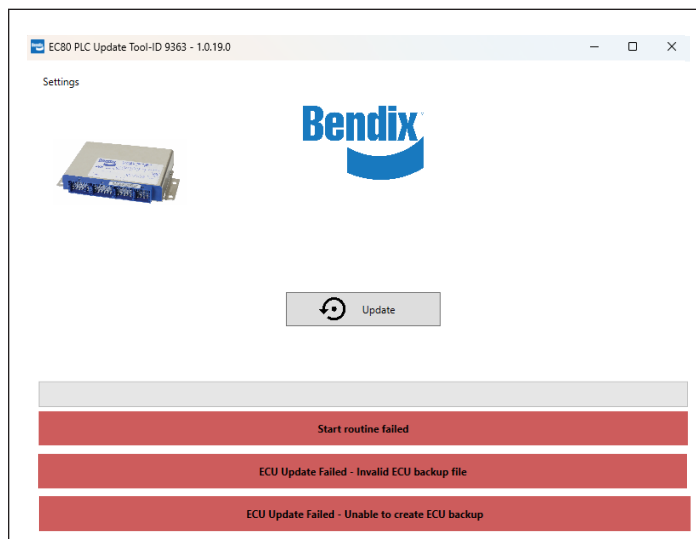
**Figure 3 – Update Failed**

- If the update fails, one of the error messages in *Figure 3* may appear.
  - » Power cycle the vehicle and restart the update procedure from Step 1.
  - » If the error returns after performing Step 1, contact Bendix Technical Support for assistance.

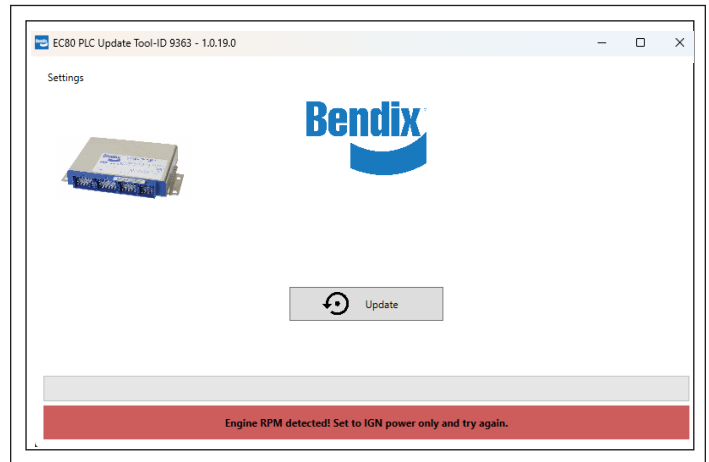
**Figure 6 – Engine RPM Detected**

- If engine RPM is detected during the procedure, power cycle to ignition only and restart the update procedure from Step 1. See *Figure 6*.

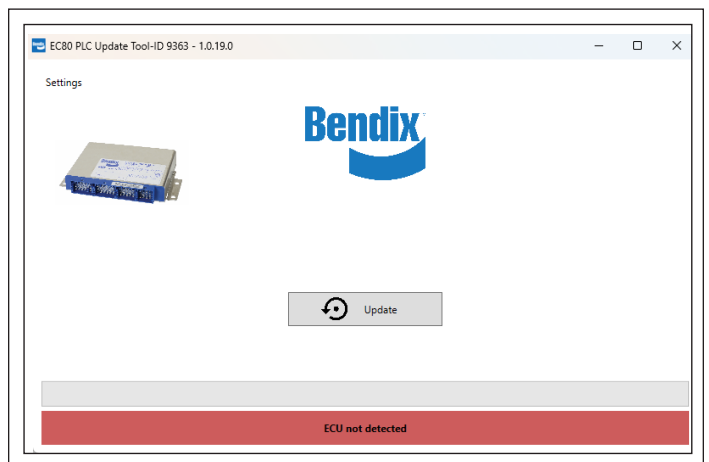
**Figure 7 – ECU Not Detected**

- If the ECU is not detected, verify the ignition power is ON and/or ensure that the correct adapter channel is selected. Then, restart the update procedure from Step 1. See *Figure 7*.

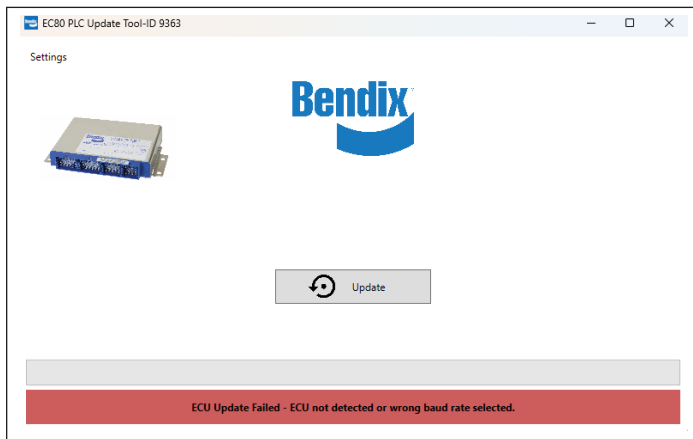
**Figure 8 – Incorrect Baud Rate or ECU Not Present**

- If the incorrect baud rate was selected or the ECU is physically not present on the J1939 bus, the screen in *Figure 8* may appear. Perform the following troubleshooting steps.
  - » Open the settings within update utility and verify the proper adapter, baud, and channel are selected. Contact Paccar® for proper channel and baud rate designations.
  - » Check the fuses related to the ABS battery and ignition.

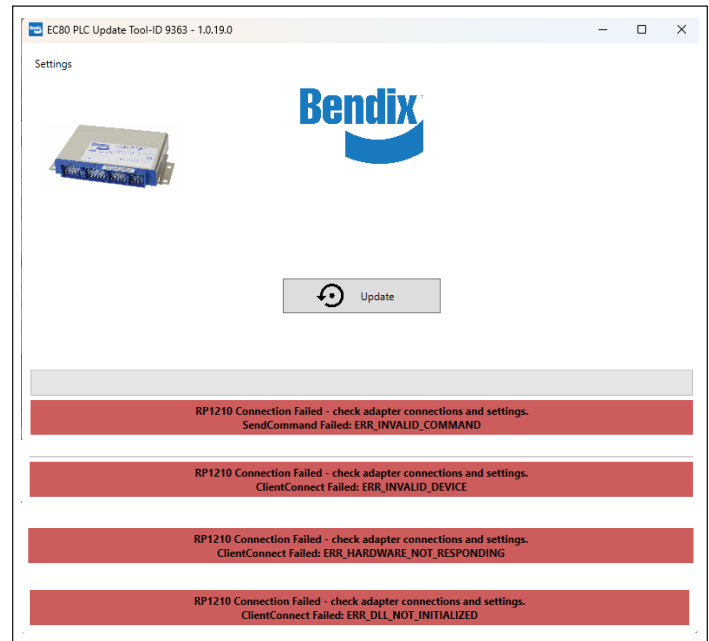
**Figure 9 – Adapter Connectivity Issues**

- If the utility is having issues connecting to the adapter, one of the error messages in *Figure 9* may appear. Perform the following troubleshooting steps.
  - » Verify the adapter has power and is reading the vehicle data. Refer to the technical documentation for the applicable adapter.
  - » Open the settings within update utility and verify the proper adapter, baud, and channel are selected. Contact Paccar for proper channel and baud rate designations.
  - » Disconnect and reconnect the adapter from both the USB port and the vehicle diagnostic port.
  - » Close all open diagnostic programs and reattempt the software update.
