# Technical Bulletin

Bulletin No: TCH-27-008 Rev 001

Subject: **Recall of Bendix® EC-80™ Electronic Control Units (ECUs) used in Towing Applications – Paccar®**

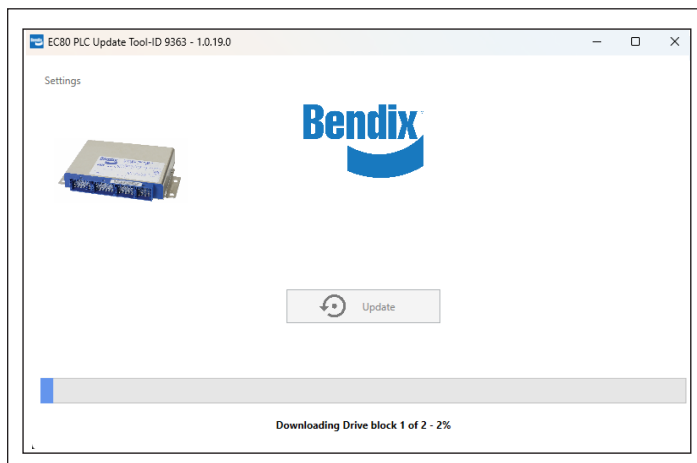
**Figure 1 – Update Icon**

1. Install the update utility that was distributed by Paccar®.
2. Plug an adapter to the diagnostic port located under the steering wheel.
3. Key on the vehicle and inspect the vehicle dash to see if any warning lamps are illuminated before beginning the update process.
4. Open the Bendix® EC-80™ update utility from the connected laptop and click *Update*. **NOTE:** Audible alerts may sound and warning lamps may illuminate on the vehicle dash during the update process. See *Figure 1*.

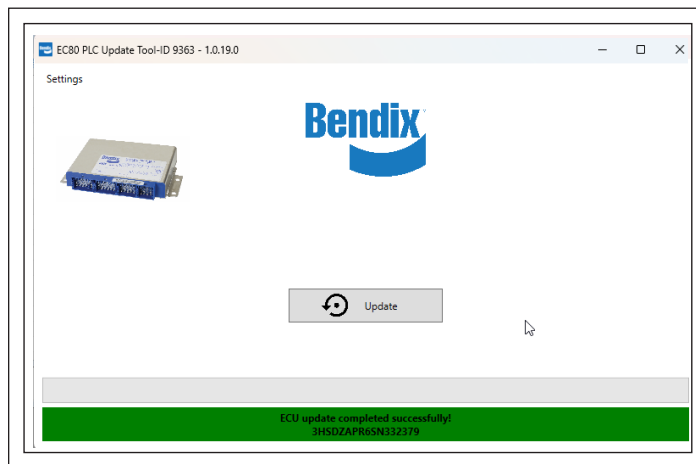
**Figure 2 – Update Successful**

5. Once the update has started, the screen will show the progress.
  - If the update is successful, the screen will show that the software has been updated, and the procedure is complete. See *Figure 2*. Follow Paccar guidelines to document the software update.

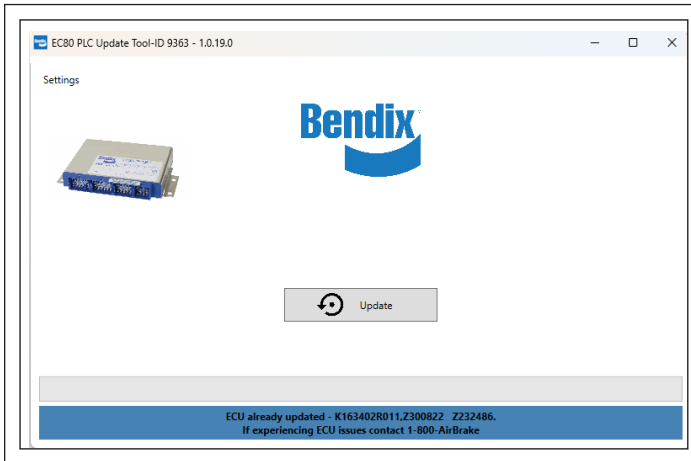
**Figure 4 – Update Already Performed**

- If the update has already been performed, a message will indicate that no further action is required. See *Figure 4*.

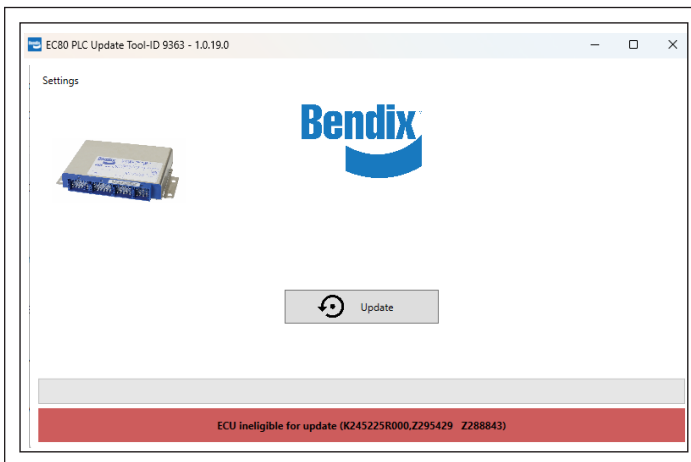
**Figure 5 – ECU Ineligible for Update**

- If the detected ECU is not eligible for an update, a message will indicate that no further action is required. See *Figure 5*.
