Action Required For Identifying the Recalled Bendix® TR-3™ Valve

Identifying TR-3 valves covered in this field action

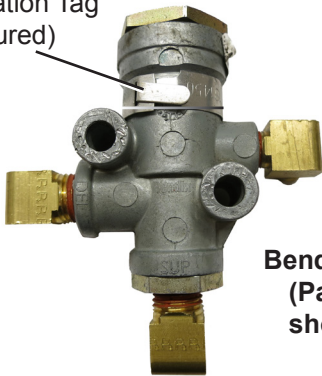
Identification Tag
(secured)

Bendix® TR-3™ Valve
(Part No. 101450
shown on valve)

To verify that the Bendix® TR-3™ valve (P/N 101450 displayed on the valve) has been replaced per the recall campaign, look for the presence of a green cable tie secured to the valve body.

Green Cable Tie
(supplied in recall replacement kit)

No further action is required.

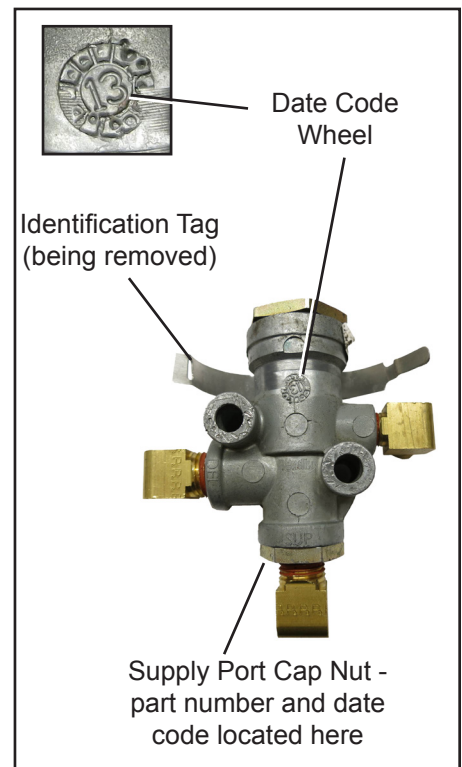
1. **The TR-3 valve covered by this recall should have an identification tag with “SPECIAL TR-3 REPLACE WITH 101450” stamped into it.** This tag may need to be removed from the valve if the view is obstructed. All other part numbers referenced are not a part of the campaign.
2. **Under the identification tag is the valve casting date code wheel.** Only **body castings with a number 13 in the center** are a suspect valve. Valve bodies that have a number other than 13 are not a part of the campaign.

The valves that are suspect must be removed to verify the part number and the date of manufacture—stamped into the supply port cap nut. To view this information the valve cap nut area must be cleaned of paint and debris. To verify the date code see *Interpreting the Date Code* below.

A date code is stamped (not cast) on the TR-3 valve supply port cap nut. *Locate the date code – removing the paint coating, if necessary – to read the code.*

- The first field is the month (A=January, B=February, etc. – excluding the letter I – so that J=September, and so on).
- The next two fields are the date (e.g. 06=6th day of the month)
- The next two fields are the year (e.g. 14=2014).
- The final code in the sequence is the Plant Code (T for all valves in this campaign)

February 6, 2014 through October 15, 2014
That is, B0614T through K1514T

Action required. Contact your OEM dealer to schedule the replacement of your TR-3 valve.
