Action Required For Identifying the Recalled Bendix® SR-5™ Valve

Identifying SR-5 valves covered in this field action

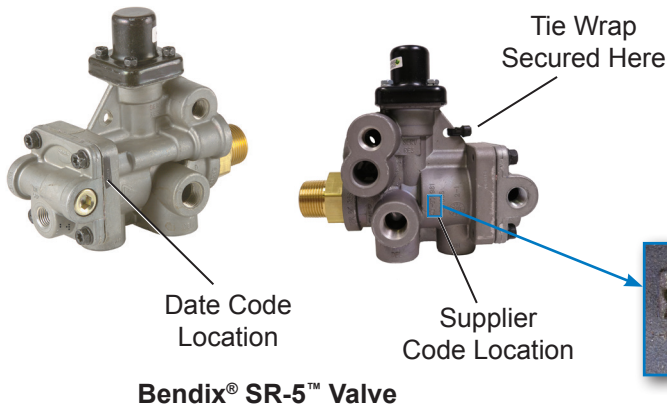
How do I know if the valve has been replaced on my vehicle?

To verify that the Bendix® SR-5™ valve has been repaired per the recall campaign, look for the presence of a black or green tie wrap secured to the valve body. **No further action is required.**

1. The supplier code – “IKD” – cast in the body and located as shown in the illustration above; and
2. The date of manufacture between January 1, 2014 and March 4, 2016, inclusive. To verify the date code see *Interpreting the Date Code* below.

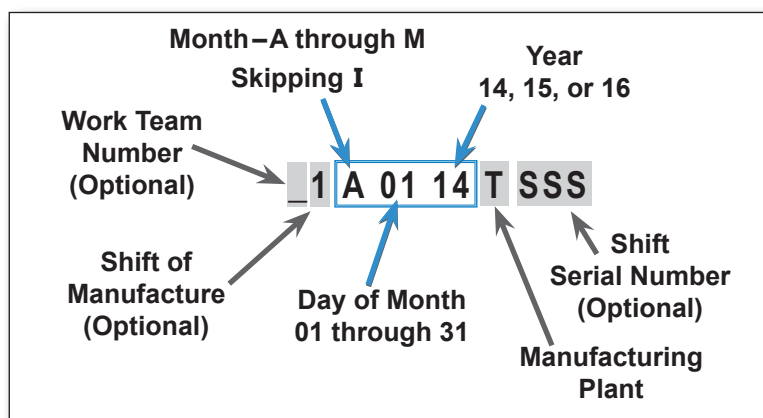
A date code is stamped (not cast) on the SR-5 valve body housing. *Locate the date code – removing the paint coating, if necessary – to read the code.* Disregard the Work Team Number, Shift of Manufacture, Manufacturing Plant and Shift Serial Number codes shown in gray below. The portion of the date code that determines the date of manufacture is highlighted and can be interpreted as follows:

- The first field is the month (A=January, B=February, etc. – excluding the letter I – so that J=September, and so on),
- The next two fields are the day of the month (e.g. 01 = 1st); and
- The next two fields are the year (e.g. 14=2014)

Valves included in this field action were manufactured during the period:

January 1, 2014 through March 4, 2016

That is, A0114T through C0416T
